## Specific Site Assessment for Coal Combustion Waste Impoundments at Thomas Hill Energy Center

Clifton Hill, Missouri

June 2011

Project Number: 092884

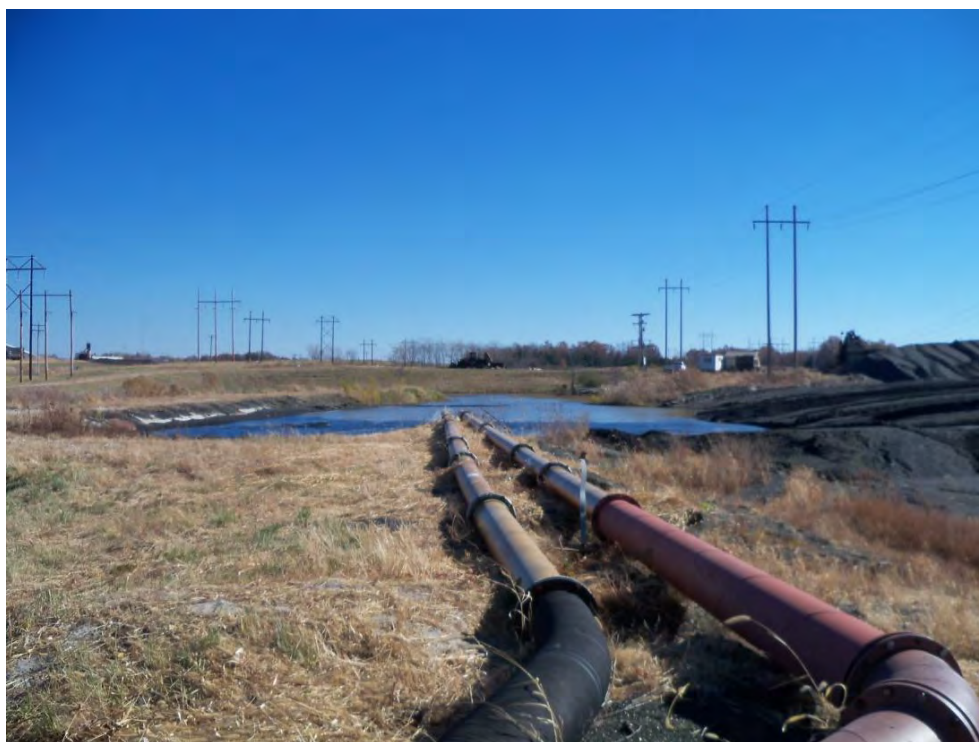
**Photo 1: Looking east at Slag Dewatering Basin inlet.**

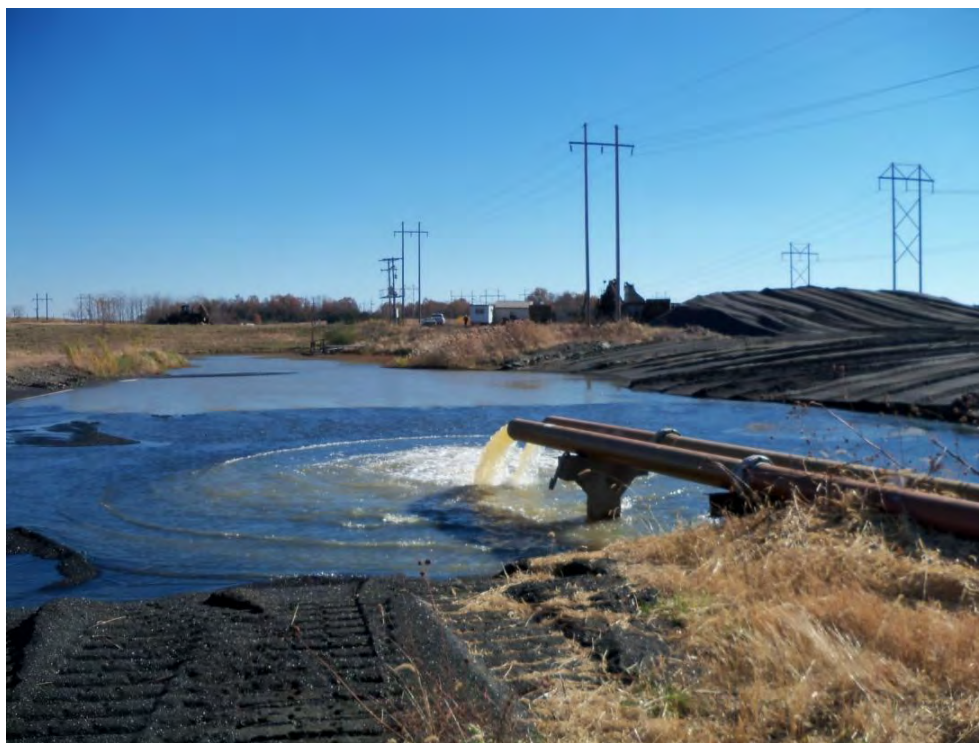
**Photo 2: Inlet pipes discharging into the Slag Dewatering Basin.**

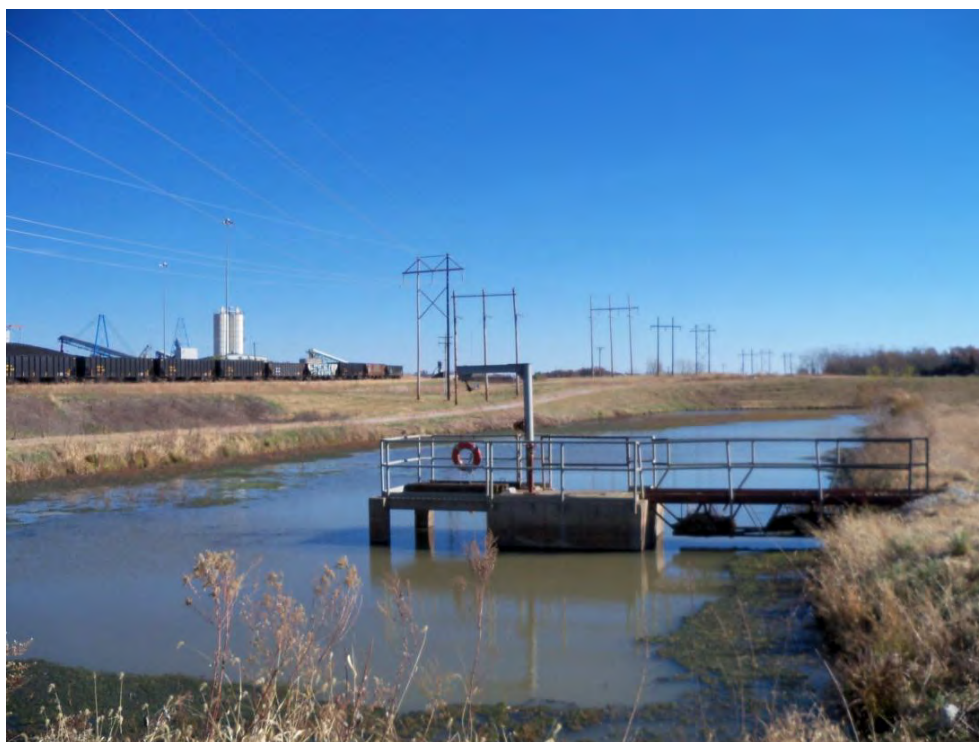
**Photo 3: The outlet structure for the Slag Dewatering Basin.**

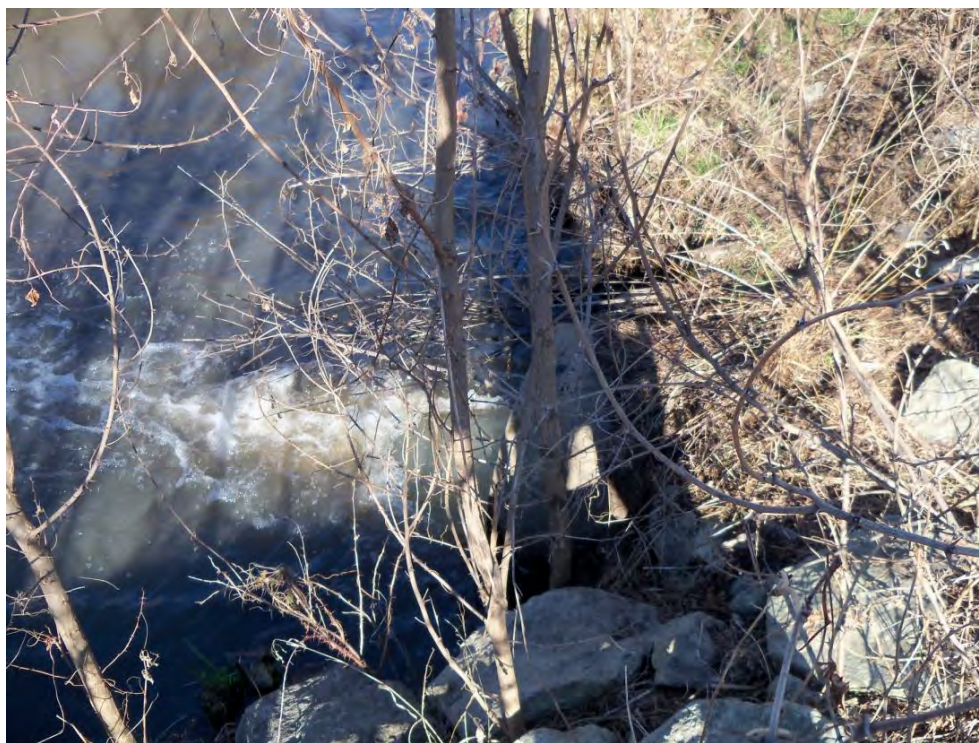
**Photo 4: Water from the Slag Dewatering Pond being discharged into the ditch to Ash Pond, Cell No. 2.**

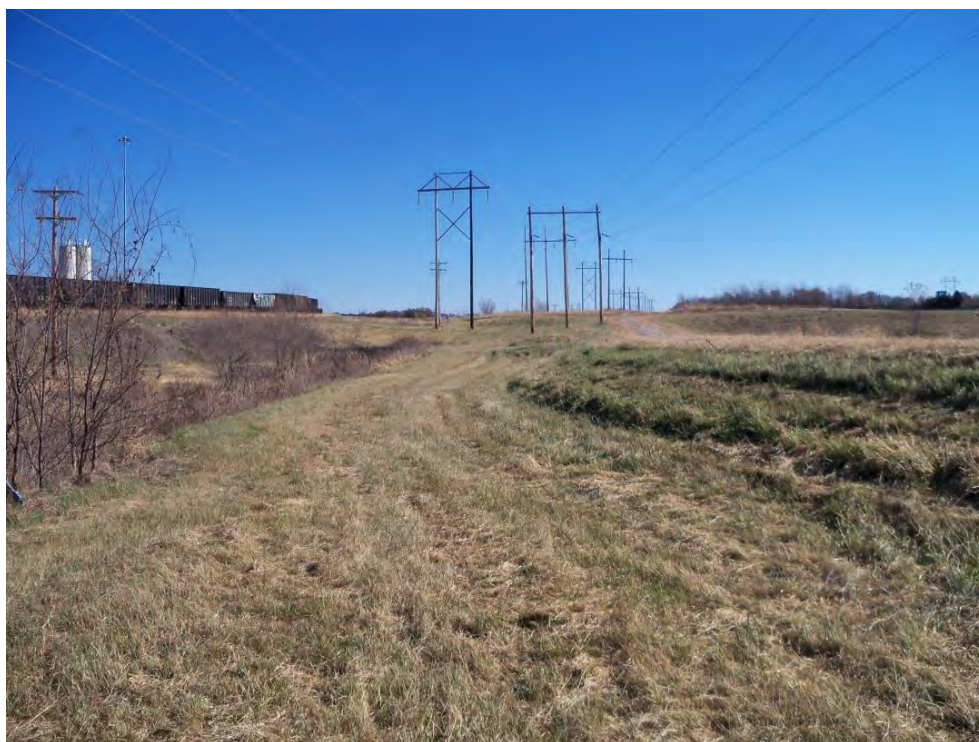
The downstream slope of the dike at the Slag Dewatering Basin generally has well-established grass growth, which provides some erosion protection (Photos 5 and 6). No scarps, sloughs, depressions or other indications of slope instability or signs of erosion were observed during the inspection of the impoundment.

**Photo 5: The north downstream dike for the Slag Dewatering Pond.**

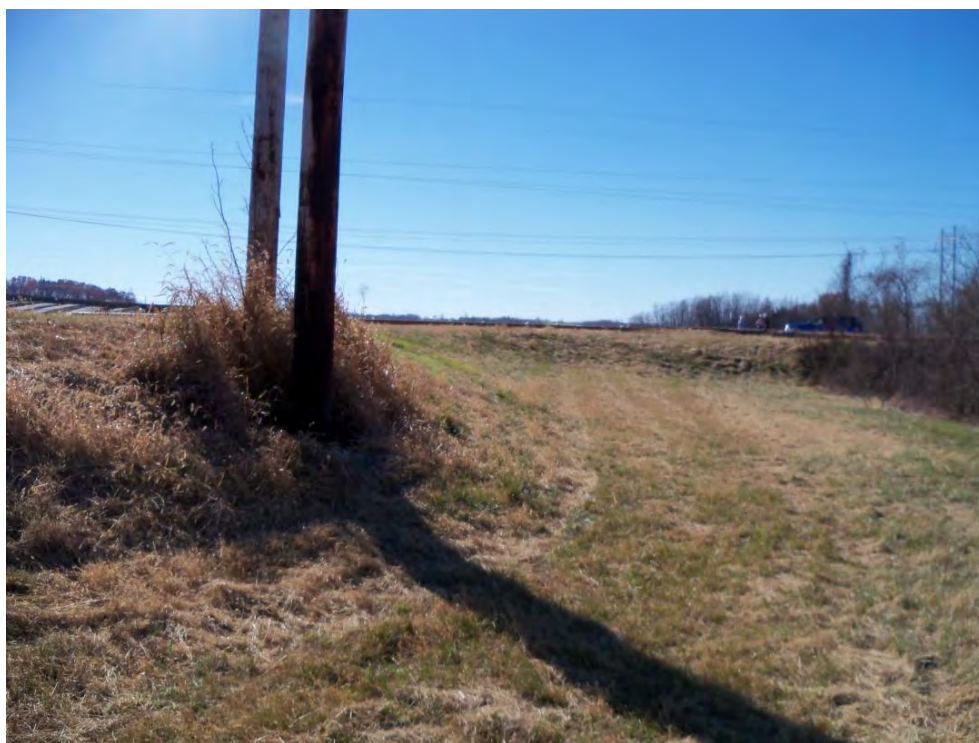
**Photo 6: The downstream slope of the west dike to the Slag Dewatering Pond.**

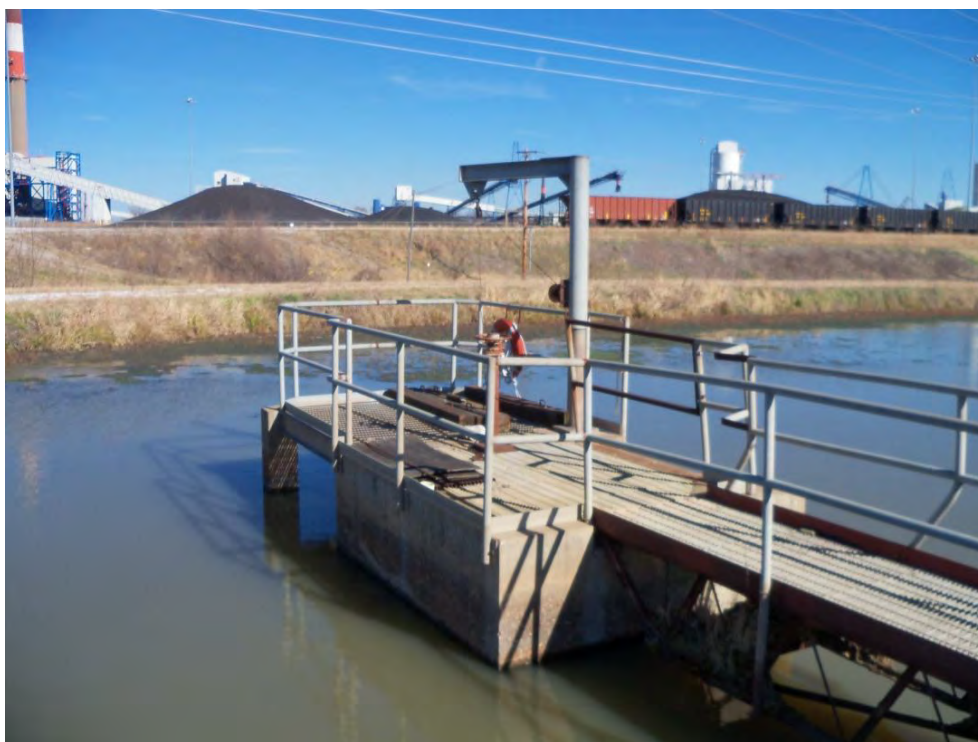
**Photo 7: The outlet structure for the Slag Dewatering Pond.**

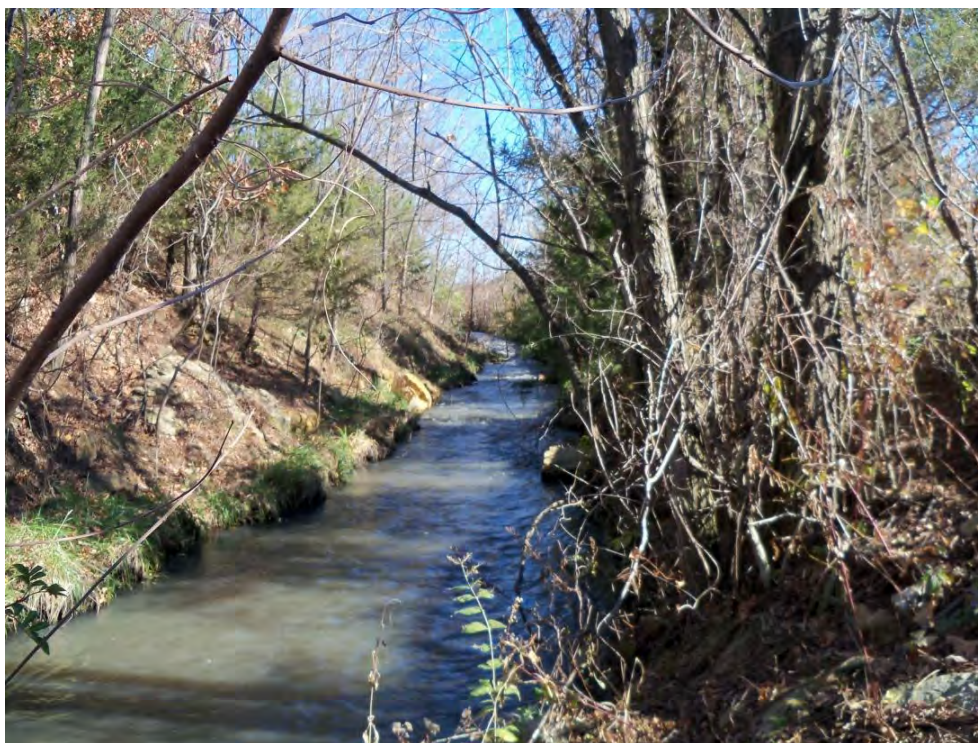
**Photo 8: The ditch from the plant that conveys water to Ash Pond – Cell No. 2.**

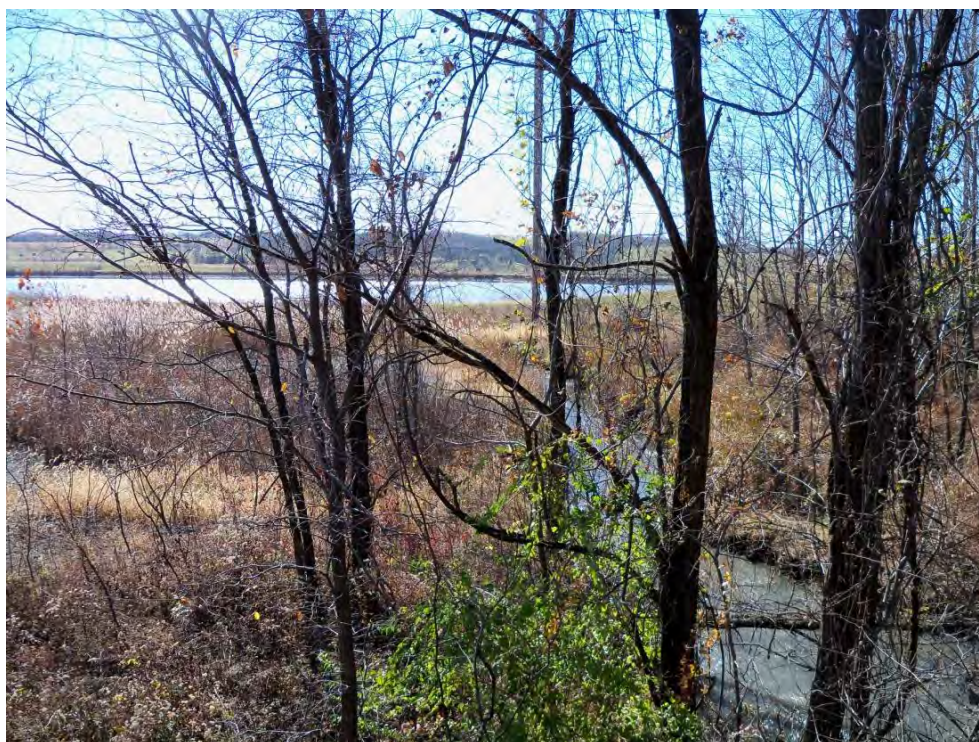
**Photo 9: The ditch outlet into Ash Pond – Cell No. 2.**

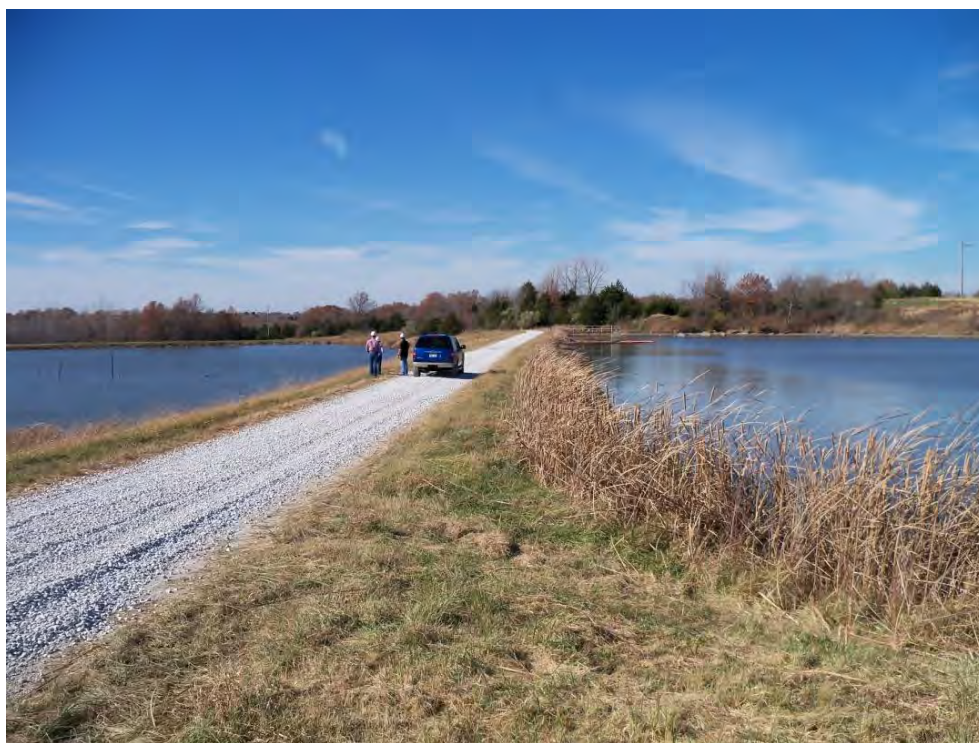
The upstream slope (Photos 10, 14, 15 and 18) of the dike at the Ash Pond – Cell No. 2 is partially covered with small riprap near the toe and well established grass growth near the crest of the embankment. The remaining slope is unprotected. No scarps, sloughs, depressions or other indications of slope instability or signs of erosion were observed during the inspection of the impoundment.

**Photo 10: Taken at the east abutment, looking west at the Upstream dike slope and dike crest for the Ash Pond – Cell No. 2. Note to the left of the dike is the Ash Pond – Cell No. 3 pond.**

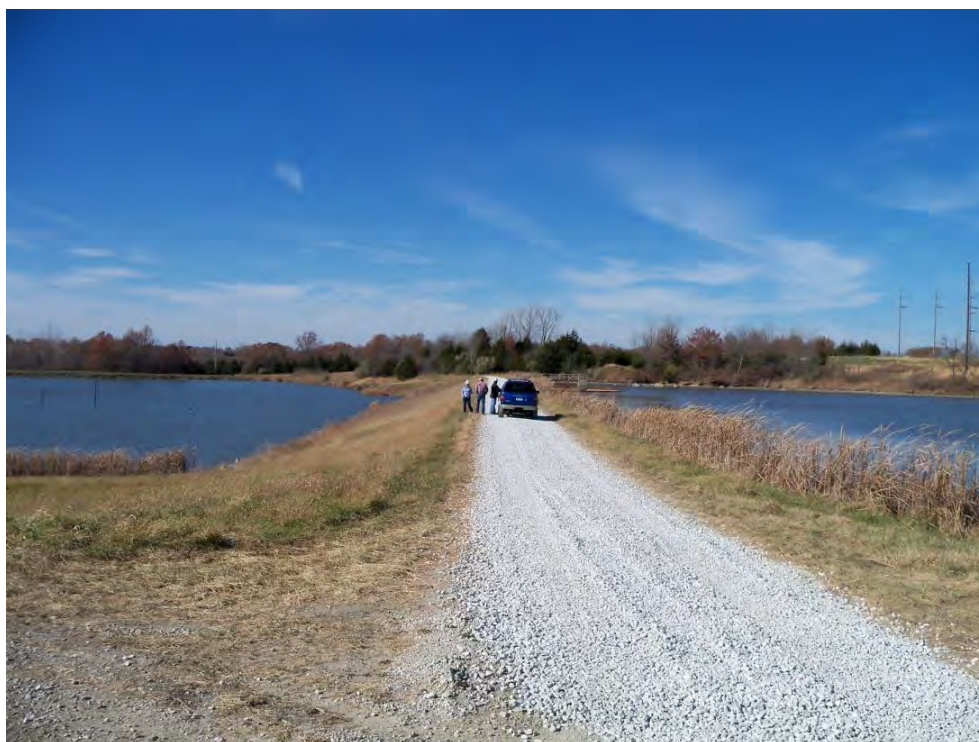
The downstream slope (Photos 11 and 17) of the dike at the Ash Pond – Cell No. 2 (which is also the upstream slope of Ash Pond – Cell No. 3) has well-established grass growth, which provides some erosion protection. At the toe of the slope is Ash Pond – No. 3. The lower 10 feet of the slope is rip rap with small to medium size rock. No scarps, sloughs, depressions or other indications of slope instability or signs of erosion were observed during the inspection of the impoundment.

**Photo 11: Taken from the east dike abutment looking west at the dike crest and downstream slope for the Ash Pond – Cell No. 2 dike.**

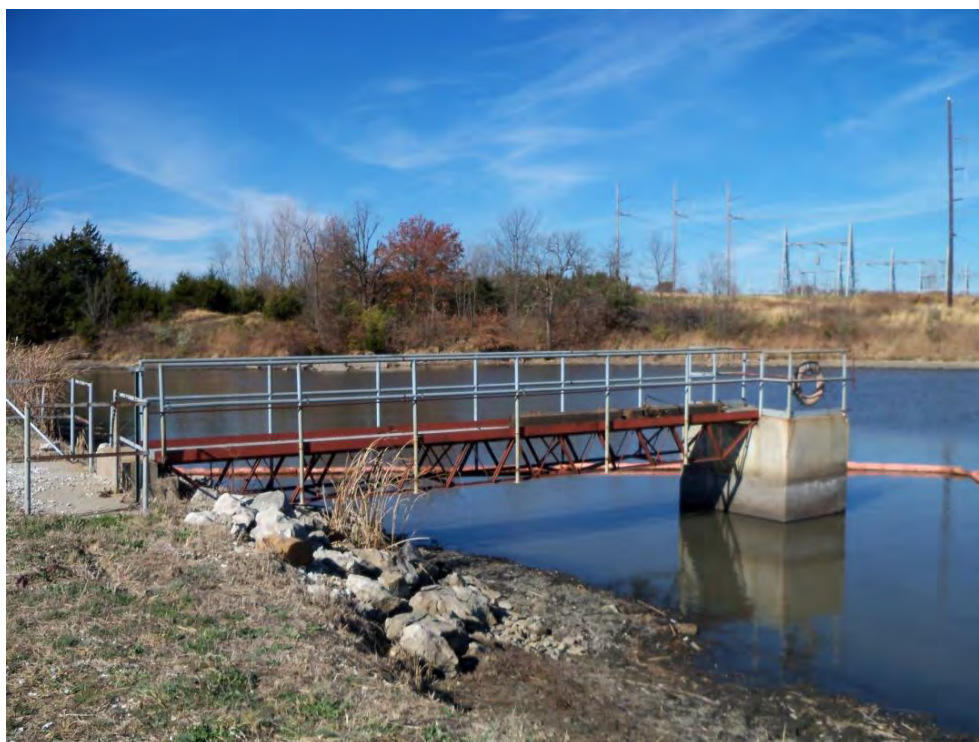
**Photo 12: The outlet structure for the Ash Pond – Cell No. 2.**

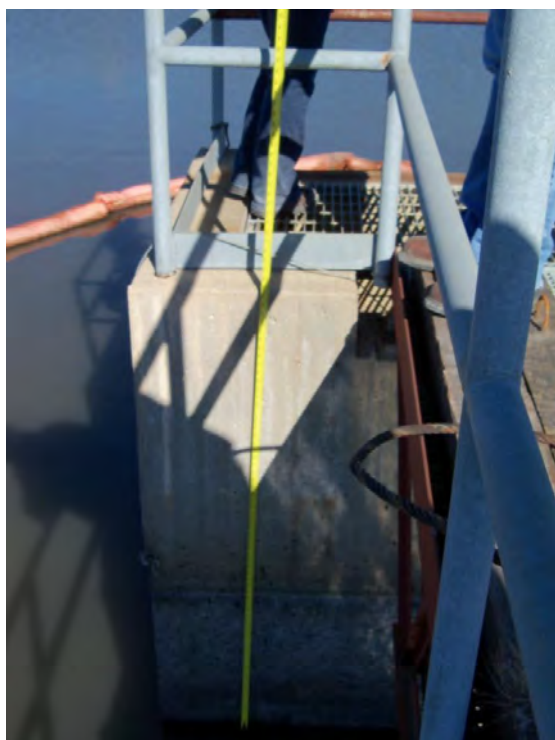
At the time of our inspection on November 9, 2010, the Ash Pond – Cell No. 2 water level was observed to be at an approximate elevation of 713 feet (Photo 13). The water surface of Ash Pond – Cell No. 2 is controlled by the outlet structure that discharges into the Ash Pond – Cell No. 3.

**Photo 13: Measuring the Ash Pond – Cell No. 2 pond level at the time of the inspection.**

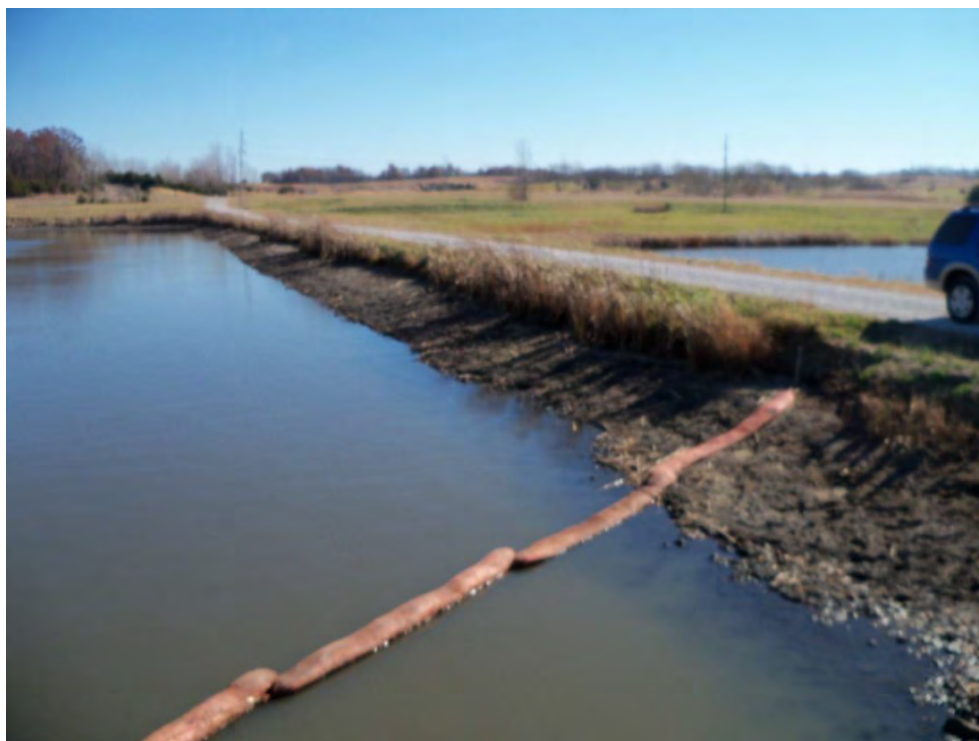
**Photo 14: Taken from the outlet structure looking east at the upstream dike slope.**

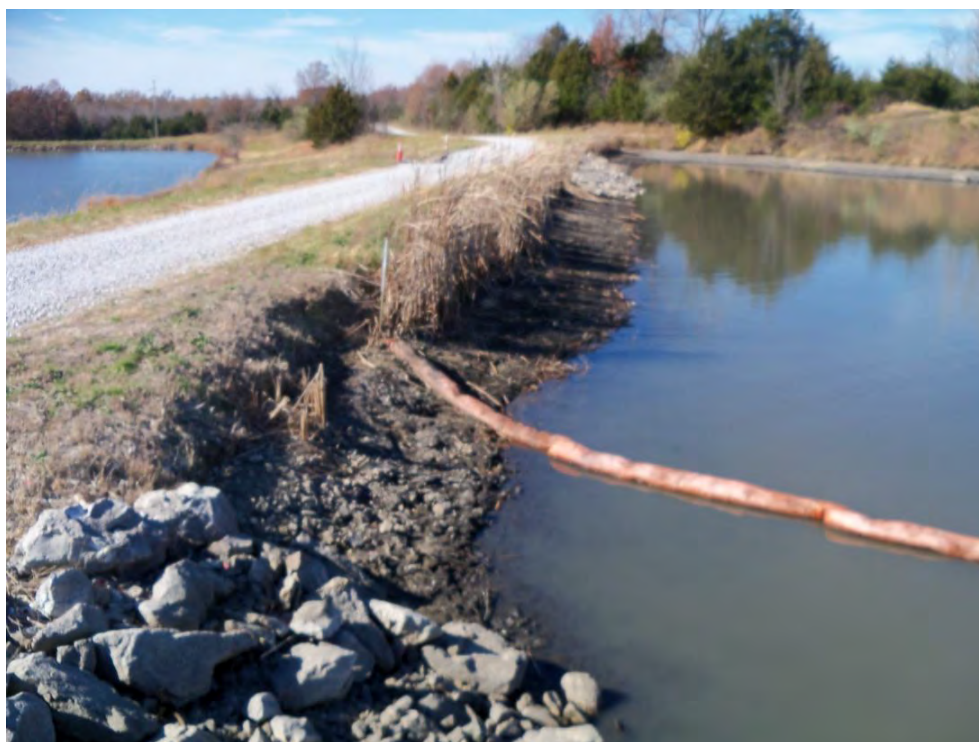
Photo 15: Taken from the outlet structure looking west at the upstream dike slope.

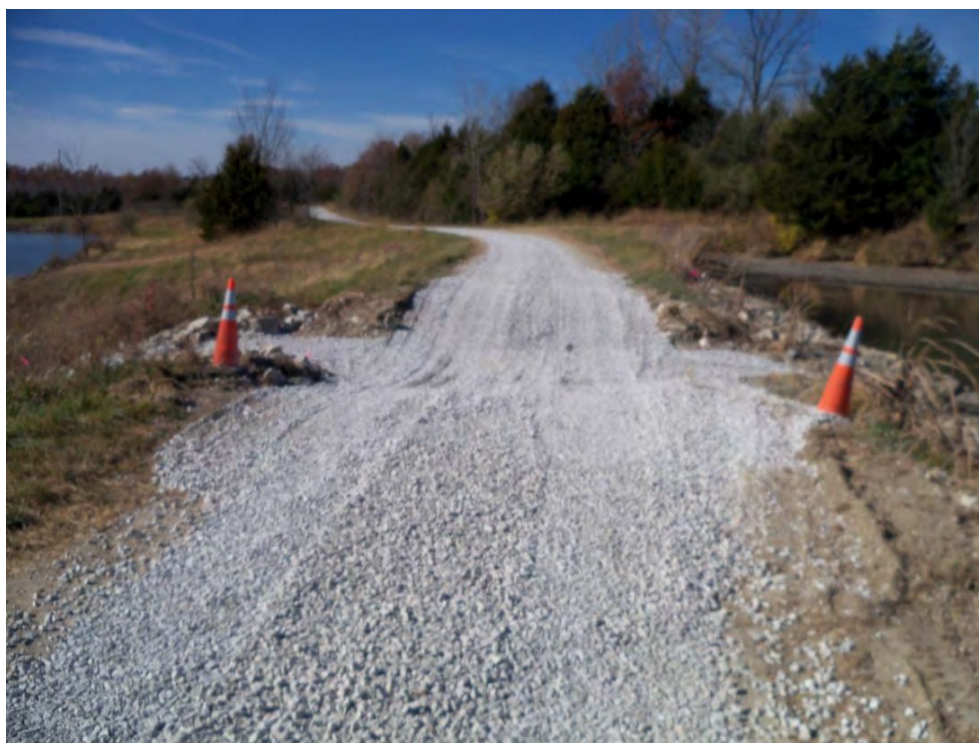
Photo 16: The Ash Pond – Cell No. 2 emergency spillway.

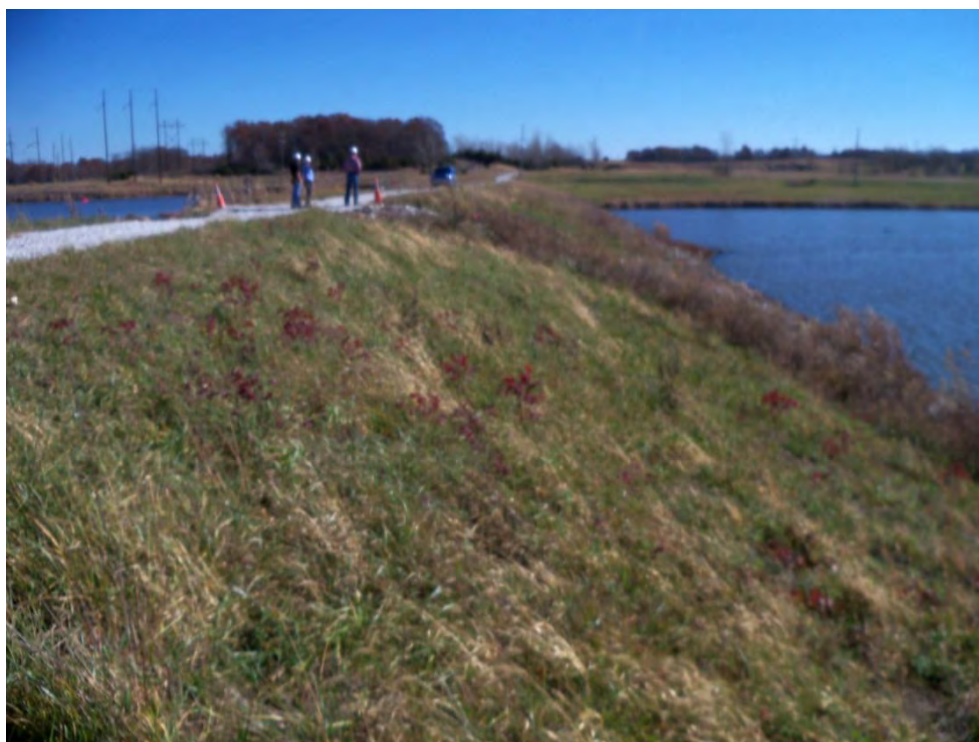
**Photo 17: Taken from the west abutment looking east at the downstream dike slope for Ash Pond – Cell No. 2.**

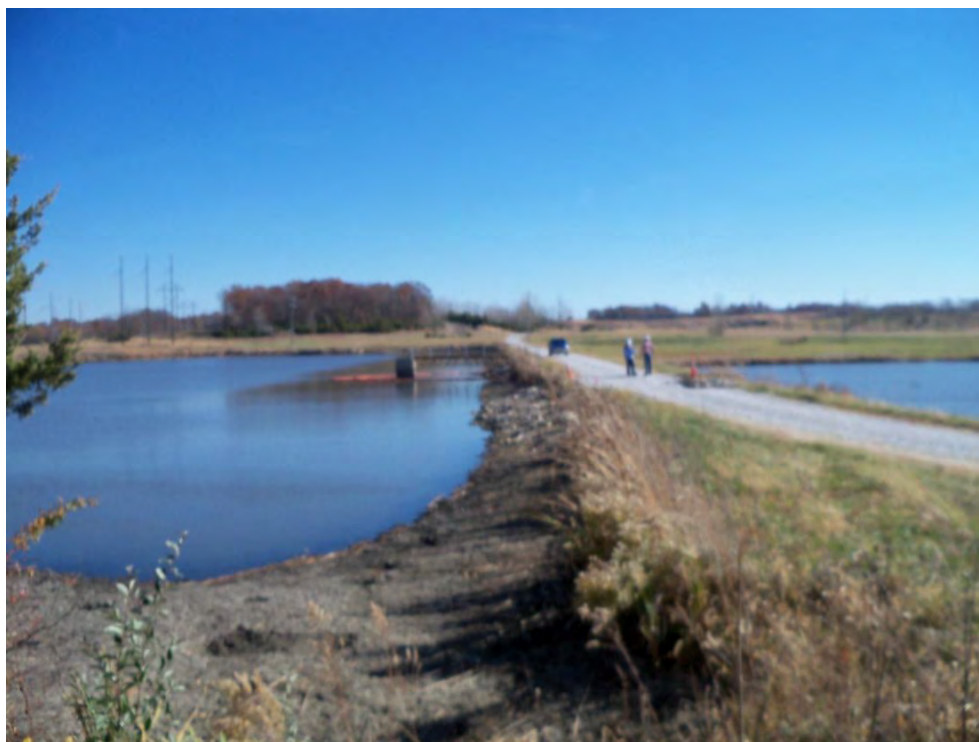
**Photo 18: Taken from the west abutment looking east at the upstream dike slope for Ash Pond – Cell No. 2.**

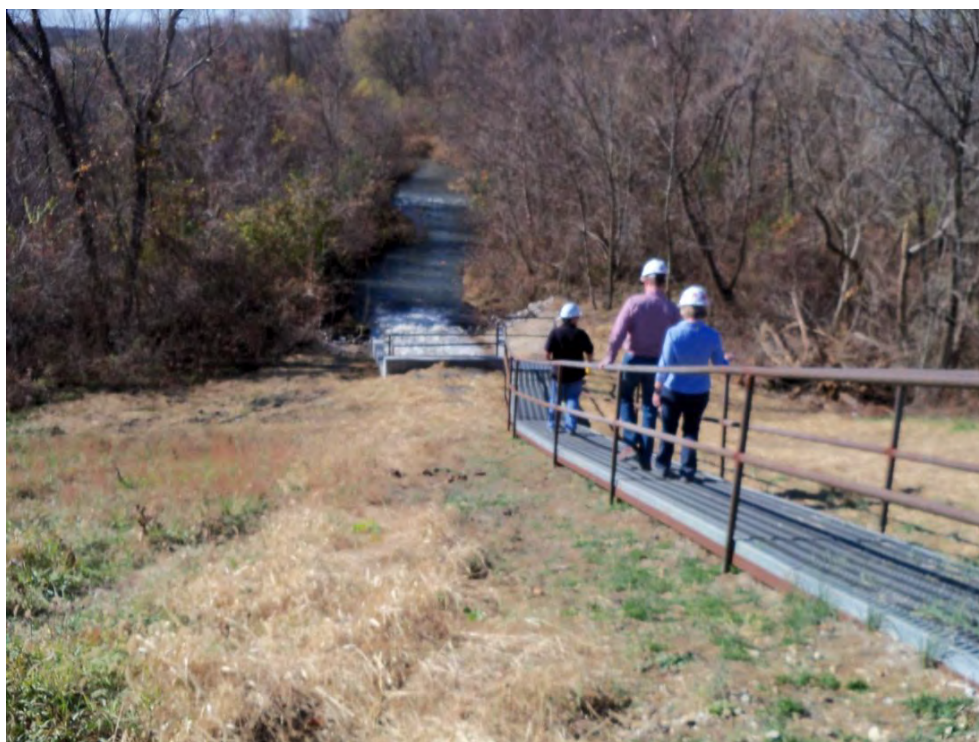
**Photo 19: Water from Ash – Pond No. 3 being discharged at NPDES Outlet No. 001.**
